Republic of the Philippines  
**COMMISSION ON AUDIT**  
Commonwealth Avenue, Quezon City

January 13, 2014

Honorable **ROGELIO L. SINGSON**  
Secretary  
Department of Public Works and Highways  
Port Area, Manila

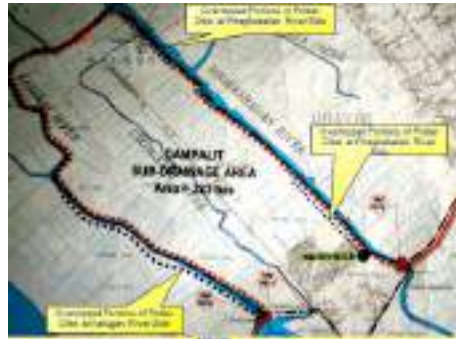
Affected area of the Polder Dike at Barangay Dampalit, Malabon City

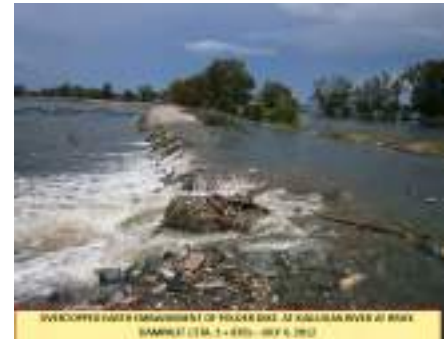
Overtopped earth embankment at Kailugan River at Barangay Dampalit, Malabon City

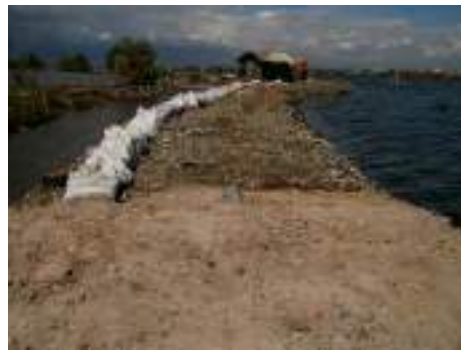
Overtopped Polder Dike

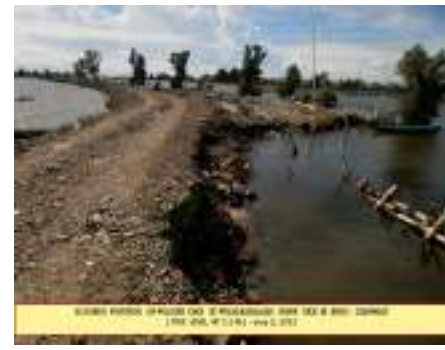
Scoured portion of Polder Dike at Pinagkabalian River side at Brgy. Dampalit (Tide level at 2.2 m – July 5, 2012)

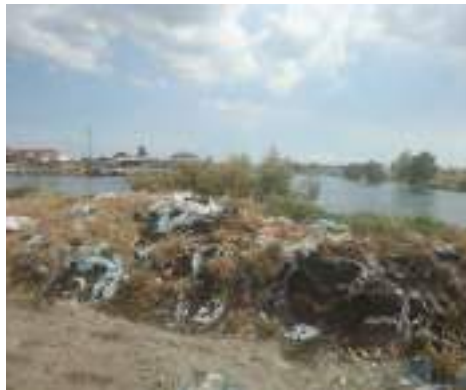
As shown below, the overtopped sections of the polder dike were not yet repaired as of date of inspection on April 23, 2013 as bags of undetermined materials were used to hold the dike.

Portion of the Polder Dike near South Pinagkabalian FG

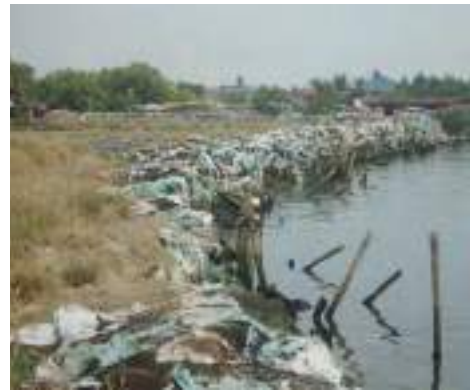
Portion of the damaged polder dike

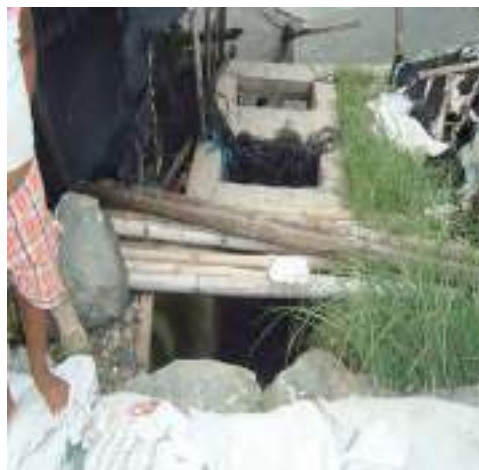
Constructed Tosang within the polder dike

During the FGD undertaken on May 22, 2013, the residents and fishpond owners of Barangay Dampalit confirmed the existence of concrete pipes or “tosang” embedded/constructed along the length of the polder dike. They said that the tosangs are used to maintain the quality (salinity) and required elevation of water of the fishponds by releasing or obtaining water from the River Side (Manila Bay). The fishpond owners admitted that some of the “tosangs” have no cover that can regulate the flow of water during high tide and heavy rainfall and prevent water to overflow and cause flooding in the nearby residential areas.

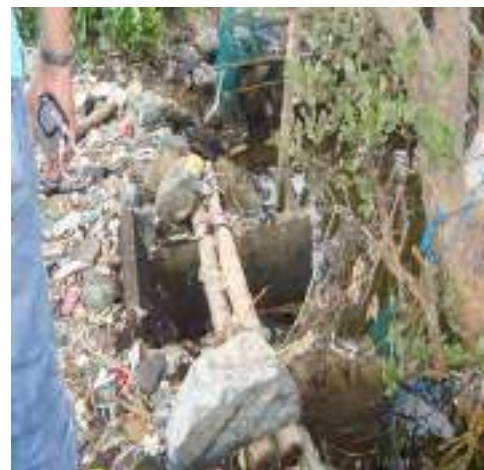
Existing Tosang along the polder dike

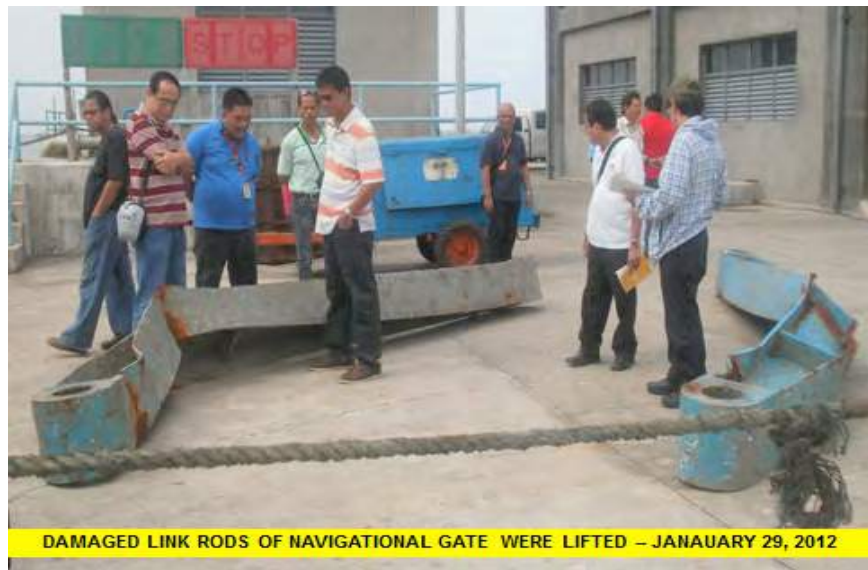
1. a crack/tear on the bottom flange of both link rods was visible; and
2. both link rods were also slightly twisted particularly near the connection with the gate leaf.

In view thereof, the DPWH organized an Inspectorate Team to thoroughly assess, investigate and determine the cause/s and extent of damage of the link rods. In its memorandum dated June 12, 2012, the Inspectorate Team concluded that the failure of the link rods was due to faulty design citing that the same were twisted symmetrically towards the same direction which suggest buckling occurred due to compression, wherein no investigation/analysis was made, as shown in the design computations submitted/presented by CTIE. The said computations showed that the link rods were designed only on its tension capacity. Moreover, they stressed that debris had accumulated in the gate pit and immediate vicinity, as the periodic maintenance dredging per prior agreement with the shipyard owners' association did not materialized and the flushing devise is not adequate to remove the type of debris usually present in the pit and in the surrounding area.

The navigation gate again temporarily ceased to operate on March 16, 2013 to give way for the installation of the permanent link rods originally scheduled from April 9 - 13, 2013 and the conduct of the necessary test thereon. However, said installation schedule was deferred pending arrival of some incidental imported materials and was reset to last week of May 2013.

The repair works was negotiated with MSB Vitug Construction Co. (MVCC) which included the replacement of link rods using of SM490 steel and the desilting of the gate itself and its immediate vicinity. However, to make the gate operational by end of March 2012, DPWH decided the use of A36 for the temporary link rods, since SM490 steel is not available locally and it will take three

4. Ensure that appropriate review of the revised design have been undertaken by CTIE and Bureau of Designs - DPWH and compliance thereon during the implementation of repair works to assure that the link rods are structurally sound;

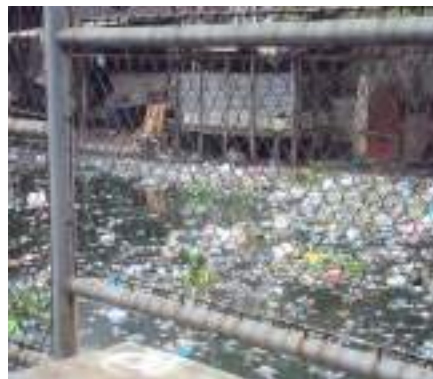
The team witnessed that all pumps and floodgates are operational. However, it was observed that the maximum suctioning capacity of the pump was not attained due to the presence of voluminous garbage that obstructs the flow of water especially at the trash rake section.

The accumulation of garbage is attributed to the presence of large number of informal settlers outside the perimeter area of the PS and FG especially in Maypajo. As observed by the team, informal settlers had also encroached the riverbank and the service roads of PS and FG and apparently have been dumping/disposing their residues or garbage to the river/creek thereon.

Garbage floating at Maypajo Pumping Station (PS)

10. Collaborate with the Barangay Officials for the continuous conduct of Information Education Campaign (IEC) regarding proper waste disposal;
11. Initiate the creation of an Inter-agency Committee that would ensure relocation sites meet the basic amenities for a suitable living condition as provided by law; and

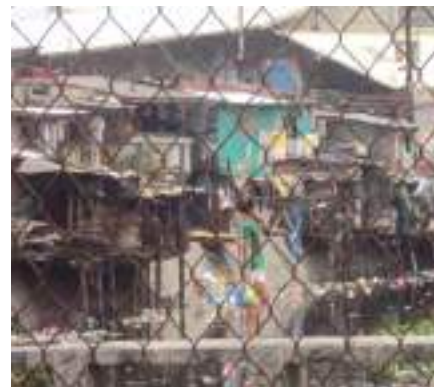
Existence of informal settlers along Maypajo PS
