Republic of the Philippines  
**COMMISSION ON AUDIT**  
Commonwealth Avenue, Quezon City

January 13, 2014

Honorable **ROGELIO L. SINGSON**  
Secretary  
Department of Public Works and Highways  
Port Area, Manila

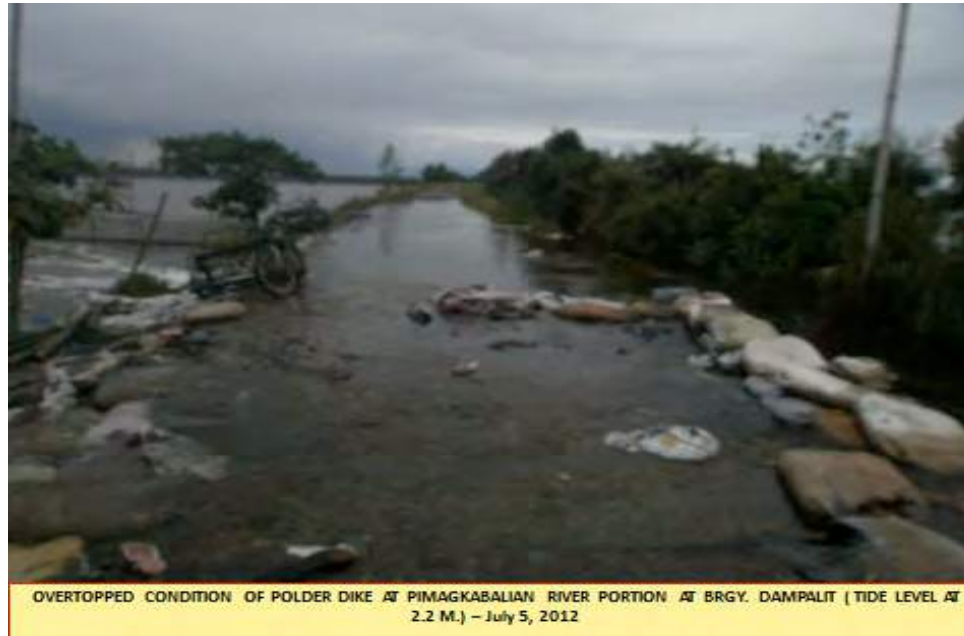
Scoured portion of Polder Dike at Pinagkabalian River side at Brgy. Dampalit (Tide level at 2.2 m – July 5, 2012)

*(Source: Flood Report – August 13, 2012 – Advisory Council City of Malabon on Flood Control)*

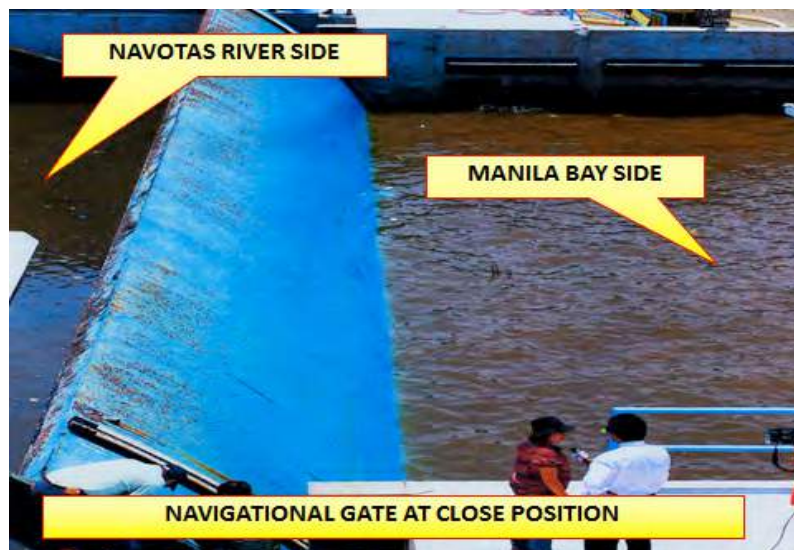
On February 24, 2011, the operator recommended the temporary shutdown of operation of the said gate on the same day, in an open position wherein the gate leaf is submerged in water due to the following defects noted during the conduct of the regular maintenance:

1. a crack/tear on the bottom flange of both link rods was visible; and
2. both link rods were also slightly twisted particularly near the connection with the gate leaf.

In view thereof, the DPWH organized an Inspectorate Team to thoroughly assess, investigate and determine the cause/s and extent of damage of the link rods. In its memorandum dated June 12, 2012, the Inspectorate Team concluded that the failure of the link rods was due to faulty design citing that the same were twisted symmetrically towards the same direction which suggest buckling occurred due to compression, wherein no investigation/analysis was made, as shown in the design computations submitted/presented by CTIE. The said computations showed that the link rods were designed only on its tension capacity. Moreover, they stressed that debris had accumulated in the gate pit and immediate vicinity, as the periodic maintenance dredging per prior agreement with the shipyard owners' association did not materialized and the flushing devise is not adequate to remove the type of debris usually present in the pit and in the surrounding area.

The DPWH Inspectorate Team recommended among others: 1) invoke the post construction liability/responsibility of the Contractor as the failure is due to inadequately designed link rods, done by sub-contractor; and 2) the Consultant should also be held equally liable for their failure to check/correct the design plans during their design review.

On March 20, 2013, the DPWH, NCCL, KL and CTIE entered into an Agreement for the cost sharing of the ₱32 million price of the repair of the damaged link rods. Parties agreed that 90 percent of the repair cost shall be shared by and among NCCL, KL and CTIE, namely NCCL to share 30 percent, KL to share 30 percent and CTIE to share 30 percent, while the remaining 10 percent shall be shared by DPWH.

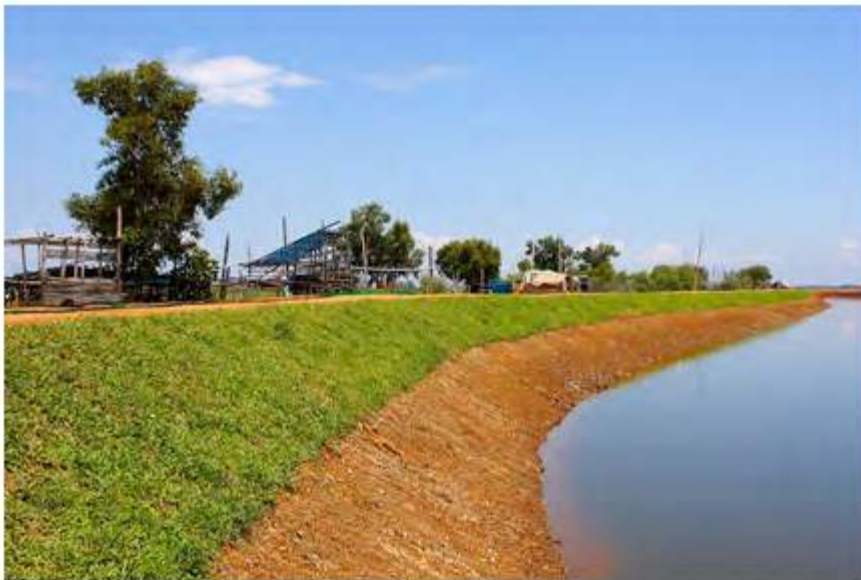
**Polder Dike  
Malabon City**

The audit team conducted ocular inspections on some of the structures constructed. Results of our ocular inspections showed, among others, that the constructed polder dike is approximately 8.6 km. However, we observed that the polder dike, constructed between fishponds, is mostly several hundreds of meters from the residential area. We also noted the existence of small gates and sluice along the polder dike.

During the FGD undertaken on May 22, 2013, the residents and fishpond owners of Barangay Dampalit confirmed the existence of concrete pipes or “tosang” embedded/constructed along the length of the polder dike. They said that the tosangs are used to maintain the quality (salinity) and required elevation of water of the fishponds by releasing or obtaining water from the River Side (Manila Bay). The fishpond owners admitted that some of the “tosangs” have no cover that can regulate the flow of water during high tide and heavy rainfall and prevent water to overflow and cause flooding in the nearby residential areas.
